**United States Air Force
15th Air Base Wing
Environmental Restoration Program**

***Final*
WORK PLAN
FOR SITE INSPECTIONS
AT AREAS OF CONCERN 18, 20, AND 21
Bellows Air Force Station
Oahu, Hawaii**

**APPENDIX B
Geophysical Survey Report for AOC 18**

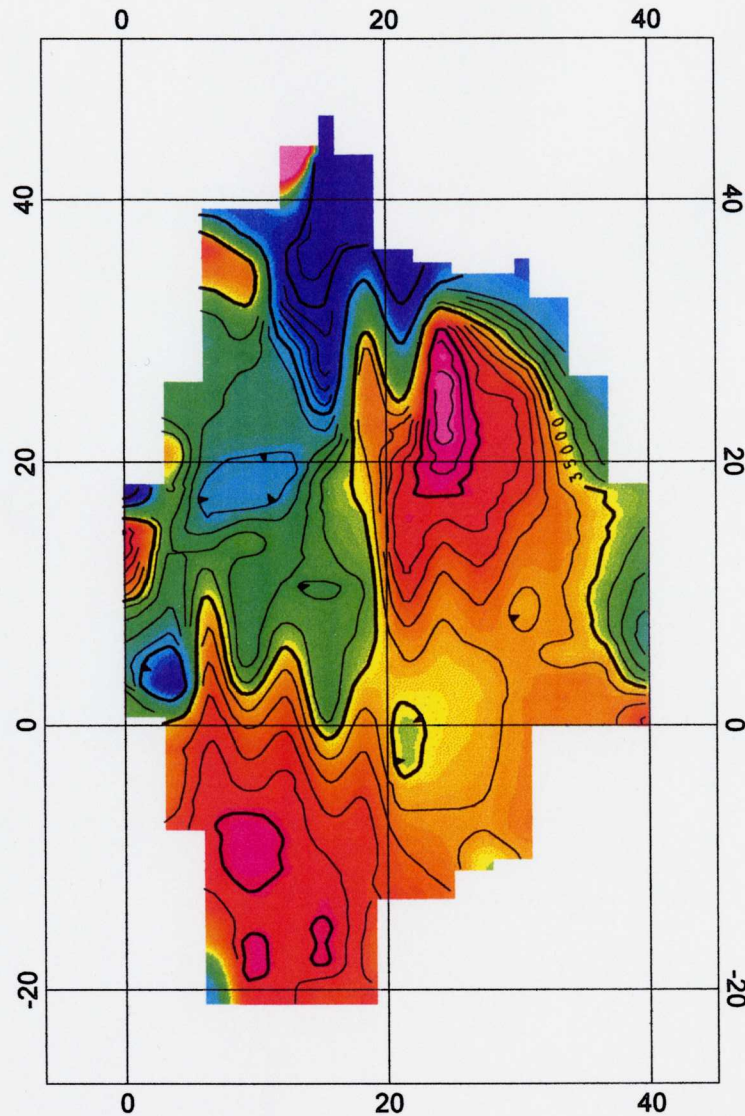
CH2MHILL
Bellows Air Force Station Total Field Magnetics
<i>Donaldson Enterprises Inc./Eric A. Brundage</i>

On 2 November 2001, Donaldson Enterprises, Inc (DEI) conducted total field magnetic and electromagnetic surveys of a sinkhole suspected of being a potential dump site. DEI's analysis of the site indicates a presence of significant amounts of metallic debris buried within the site.

The total field magnetic survey is presented in attachment A. For references, the "ramp" leading into the site lies south of the coordinates 3,0 through 31,0. The map shows indication of buried metals under the material used to compose the ramp as well as approximately 5,3 and along the northern portion of the site. A small amount of metal is indicated on the eastern edge vicinity of 5,38.
