Figure 5
Generalized Geologic Cross-Section of Site LF01
EE/CA FOR SITE LF01, BELLOWS AFS

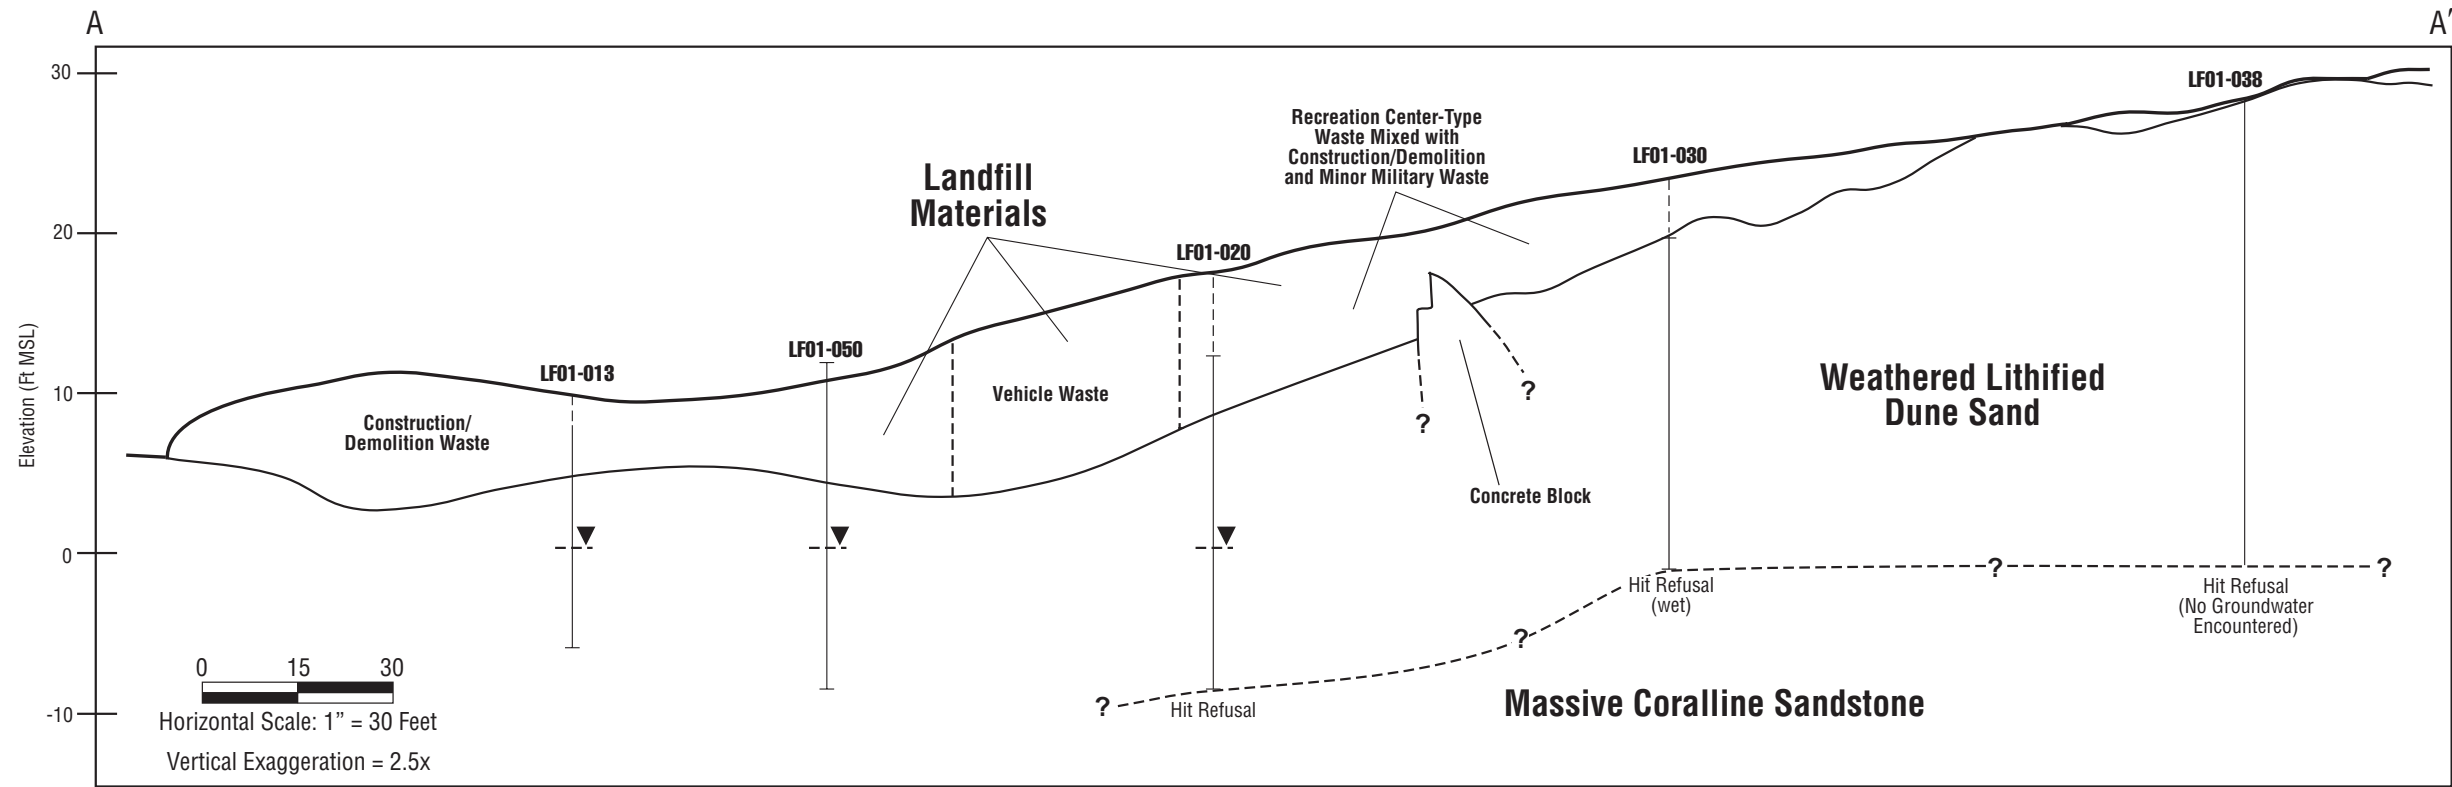
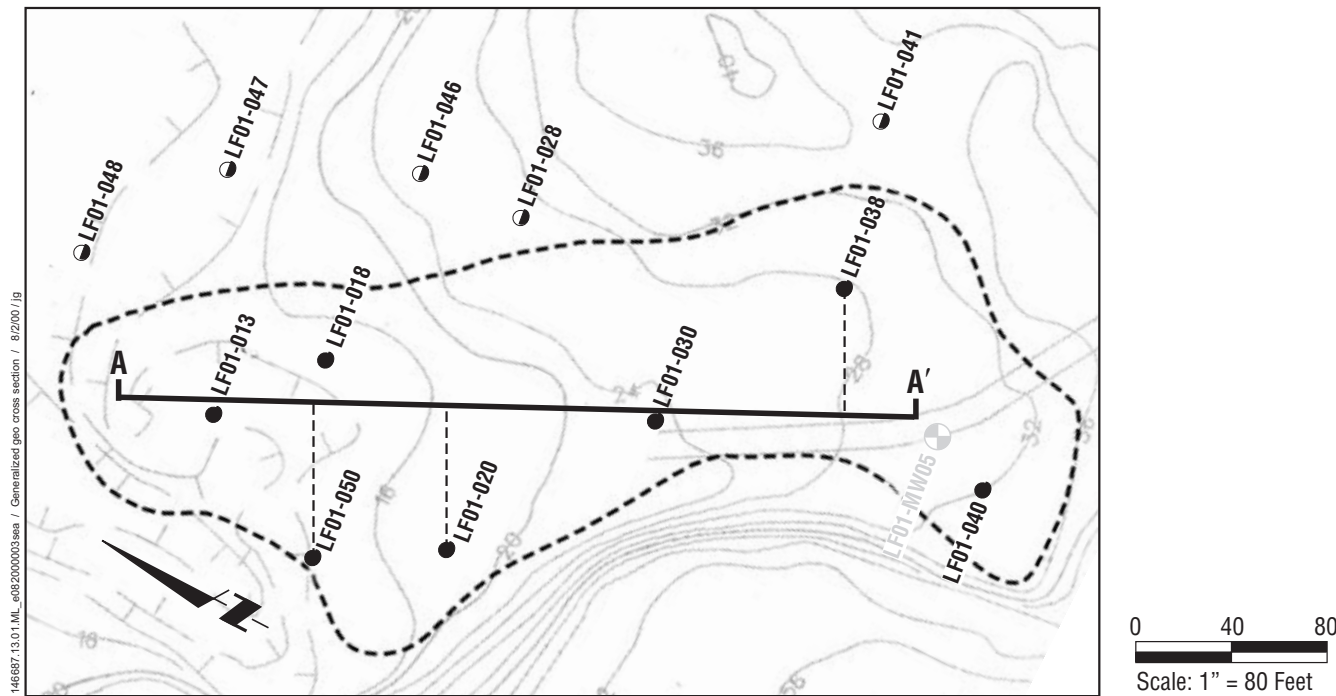
NOTES: 1) The presence of massive coralline sandstone is inferred because DPS drilling hit refusal at the depths indicated.
2) All borings are projected onto the section line.
